9 Wet Spots 2020 **Where are we after 11 years ?**

Drainage report 06

11.03.2020

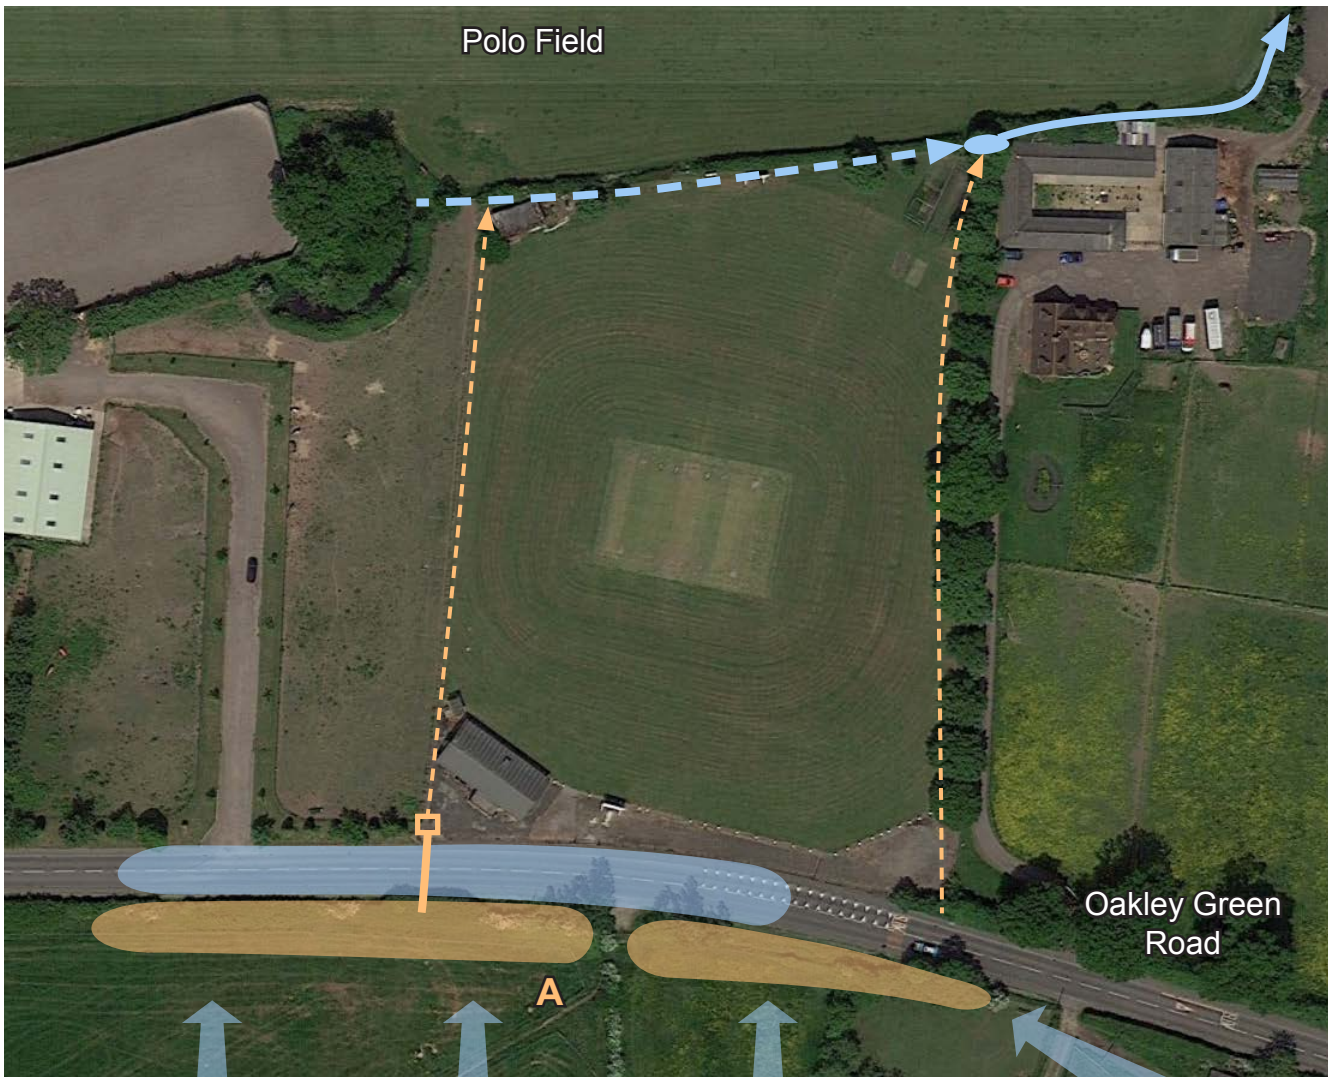
1 Cricket Ground - Oakley Green Road

Some early improvement was achieved here when in 2009 an old bucket was cleared from the manhole chamber on the south side of the Oakley Green Road. We thought this was an early success and for a while it seemed to be. But recently the flooding seems to be becoming more frequent again.

We asked Streetcare to investigate further as the Cricket Club were reporting increasing problems also. They confirmed in 2014 that the culverts crossing Oakley Green Road in the vicinity of the cricket club had again been checked and cleaned. A site meeting took place on Tuesday July 15 2014. The pitch and nets get flooded in the winter and the Oakley Green Road frequently floods along their stretch.

We believe the root cause of the road flooding is an inadequate capacity in culvert and chamber at their south west corner and the underground pipe heading north from there along their western boundary. Until such time as the capacity of this route is increased we do not expect to see any improvement.

Although happening far less frequently than in the past this site has again been briefly flooded in winter 2020 and consequently this wet spot has been returned to RED status.

We need to investigate with landowners the possibility of introducing a sump or pond area to try and hold back excess water at times of heavy rainfall. We understand that Streetcare were, and now Project Centre are, considering our earlier suggestions of delaying the arrival of water flowing towards this point and increasing the holding capacity of the ditch and ground on the southern side of the road at **(A)**. We *still* await their proposals with interest.

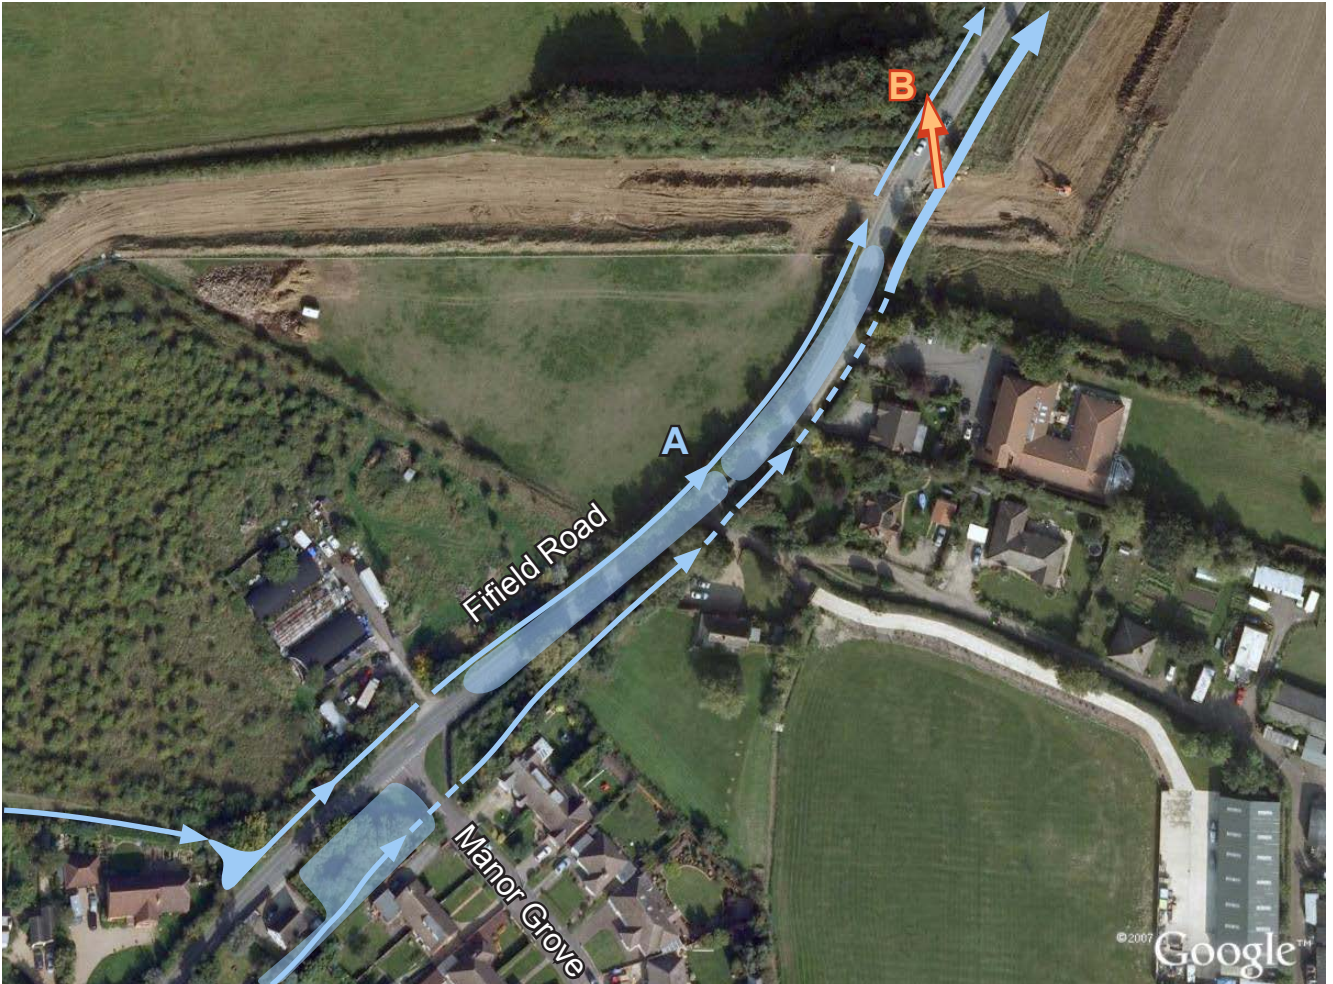
2 Speed hump and Fifield Road (north)

A protracted saga of official delays, obstruction by utilities companies, and the deployment of OGAFCAs volunteers on 2 occasions. In February 2014 Streetcare contractors finally cleared the ditch at **(A)** on the west side of Fifield Road.

While work was in progress it was noticed that a culvert north of Longlea at **(B)** was delivering water from the large eastern ditch into the smaller western stretch. Streetcare said it had been assumed to flow in the opposite direction. The subsequent large volume of water in the smaller capacity western ditch caused a problem further north when entering a pipe just north of Wayside Stables. We requested that the culvert be disabled as the large ditch seems well able to handle whatever flow arrives at that point. Streetcare confirmed that the stoppers they ordered had been installed as a trial.

Despite being cleared in 2014 by Streetcare the speed bump site at **(A)** has been regularly flooding once again in winter 2020 and we have therefore returned this wet spot to RED status. An OGAFCAs volunteer in February 2020 cleared dumped garden waste and build up of debris. But this spot in the ditch is simply too narrow and too shallow to remain clear and needs annual maintenance at least. As the landowners have repeatedly ignored requests we can only hope that RBWM will again take on this work and also include the ditches and culverts on the east side of the road.

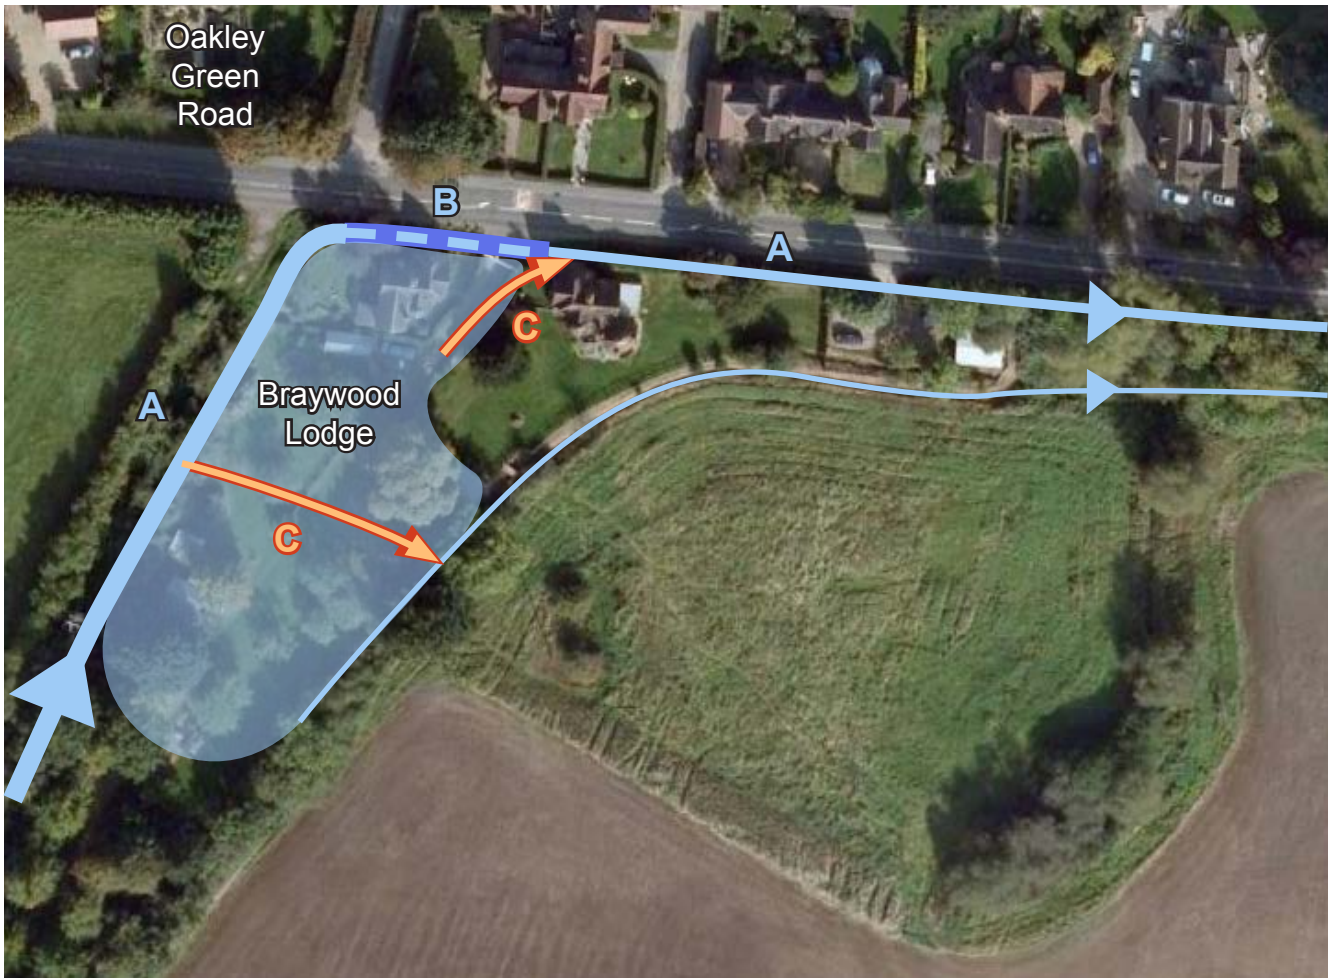
3 Braywood Lodge - Oakley Green Road

In 2011 volunteers cleared the ditches at **(A)** and Streetcare arranged jetting of pipes under the roadside verge at **(B)**.

Unfortunately the resident informed us at an open meeting in February 2014 that the problem is not resolved and that there had once more been a lot of water on the driveway. So this “wet spot” was returned to Amber status.

In March 2020 we have not received any reports of recurrence and will request an update from the landowner as soon as possible.

Streetcare promised that the pipework running parallel with the road in the vicinity of Braywood Lodge would again be checked and cleaned. This is unlikely to remove the problem completely so at the next heavy rainfall event the site should be monitored and it may be necessary to recommend land drainage piping at **(C)**.

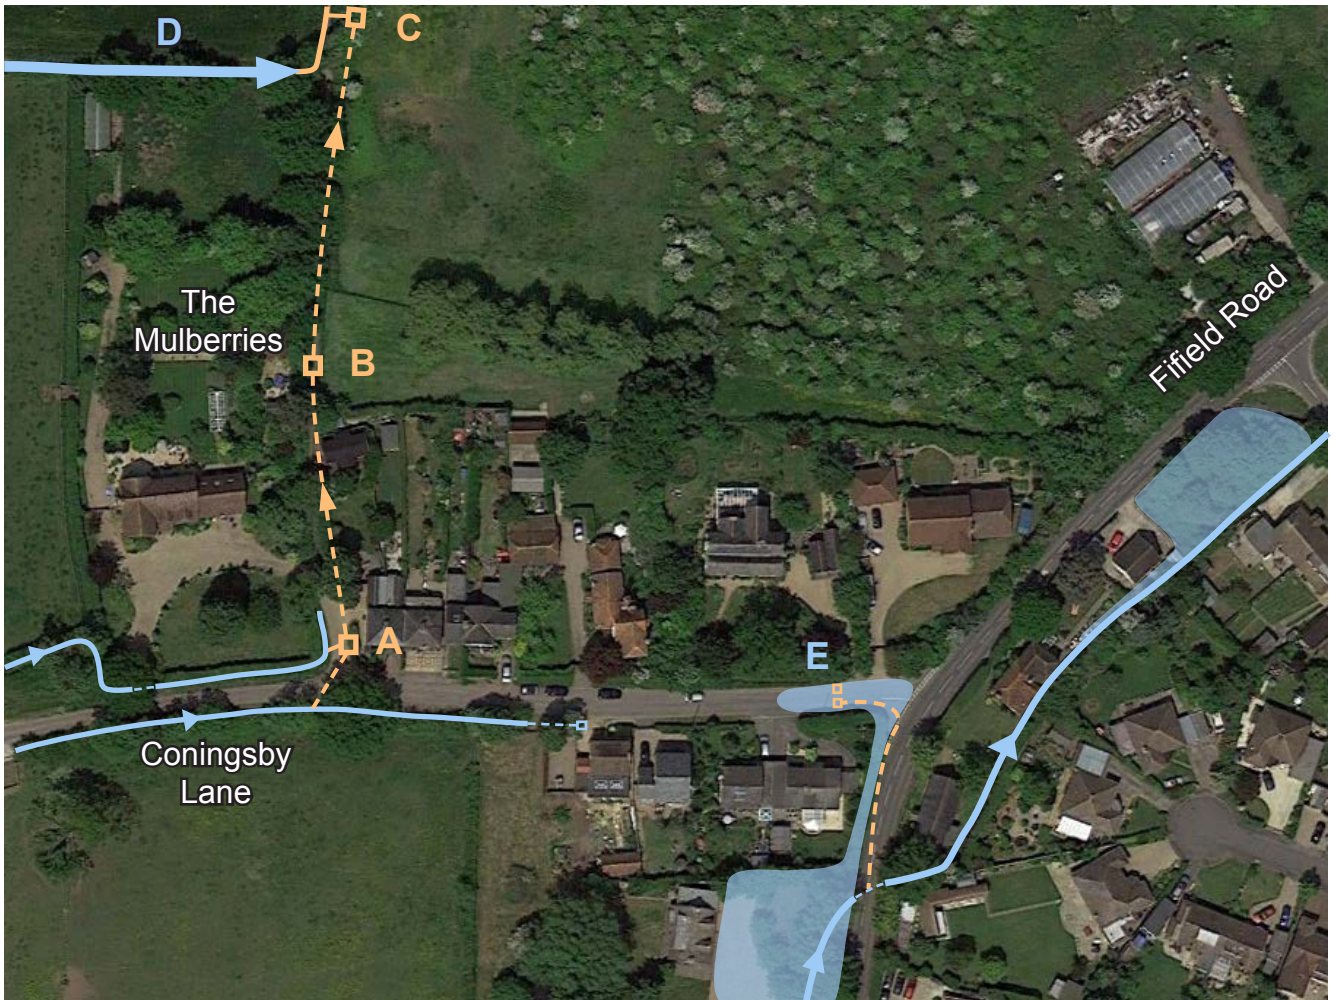
4 Coningsby Lane (north)

During the summer of 2019 RBWM Project Centre contractors finally carried out the project that has been proposed since 2001. In those early days the issue was just to re-instate the ditch that used to run along the west side of the access track (A-C). During the following years the ditch became filled in and overgrown so it became less problematic to install a large bore pipe instead.

A new culvert under the lane now takes water from the southern ditch to a chamber (A) on the north side. A new pipe from the ditch in front of the Mulberries also feeds into this chamber. From there a new pipe runs north to a chamber (B) and onward to a third chamber (C) from where a new pipe exits into the ditch. This ditch has been enlarged and regraded northward to a new pipe and chamber under the footpath and then all the way around the edge of the Biffa land to exit onto Fifield Road.

This new route has been carrying a huge volume of water northwards away from Coningsby Lane and no longer has to try to exit southwards onto Willow Creek land to try and find its way to the Fifield Road culvert and then northwards on the east side of Fifield Road. The large amount of water that has in the past collected along the northern boundary of the Mullberries (D) and saturated the rear land of the property is now finally also able to escape as always intended.

In extreme conditions there is still a collection of water (E) at the junction with Fifield Road. This is short-lived and is no longer caused by the large amount of water unable to escape, overflowing the ditches, and pouring down the road. Some of this seems to be coming from a backup from the Fifield Road culvert and it is possible that some is backing up from the same culvert when it is full through the gullies because of silted-up one way valves. These are different problems that must now be considered in their own right.

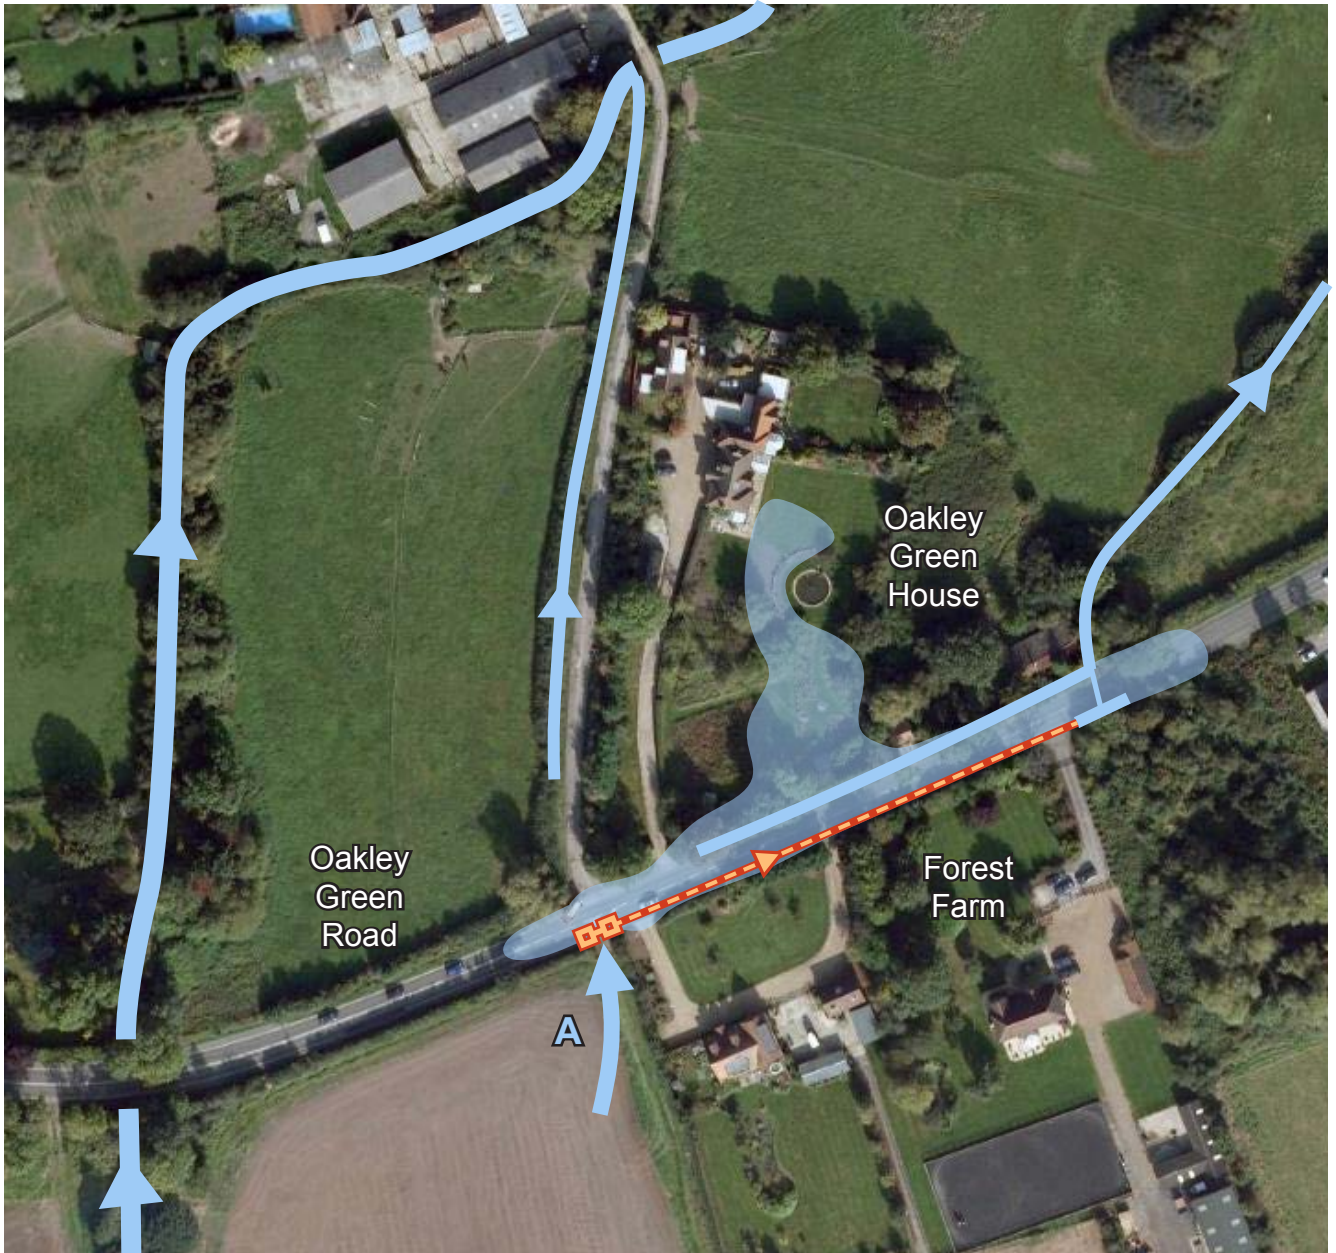
5 Oakley Green House and Forest Farm area

Large amounts of water flowing out of the field gateway (**A**) used to cause the road east of this point to flood.

Streetcare carried out a reduced version of our recommendations and installed an extra 2 gullies in the gate entrance. This appears to have improved the situation and residents report that there has been no recurrence.

So until we hear otherwise this “wet spot” has been given green status.

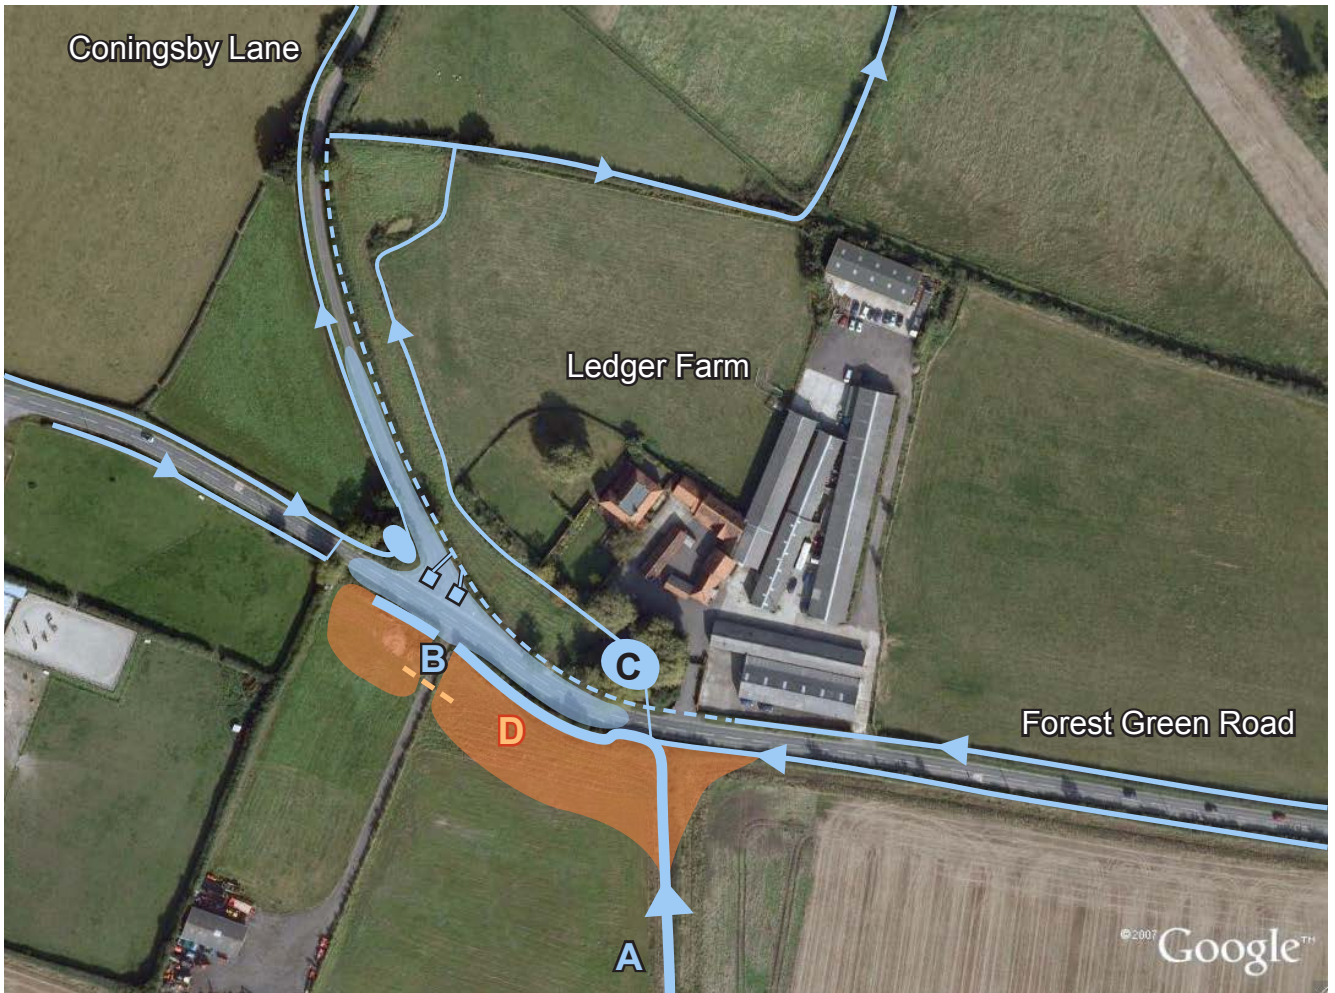
6 Ledger Farm - Coningsby Lane and Forest Green Road [Contents page](#)

Water coming down **(A)** off the high ground of the Drift Road collects on either side of an entrance **(B)** on the south side of the Forest Green Road. When the valve for the pipe under the road into the pond at Ledger Farm **(C)** is closed water can only proceed northward by spilling out across Forest Green Road and down Coningsby Lane.

We have been unable to achieve anything here yet. Suggestions made in our original report are unlikely to find Local Government funding, at least not in the short term.

Perhaps the best that can be attempted in the short term is to encourage the landowner to agree to accept much more of a sump area **(D)** on the south side of the road so as to delay the progress of large quantities of water for a little longer.

This would also have the beneficial effect of not increasing or even reducing the flow of water arriving at the north of Fifield in the front garden of Willow Creek (which used to be a pond) and trying to get under the road at the culvert there (which used to be a road bridge) to flow round the back of what was the old Chapel.

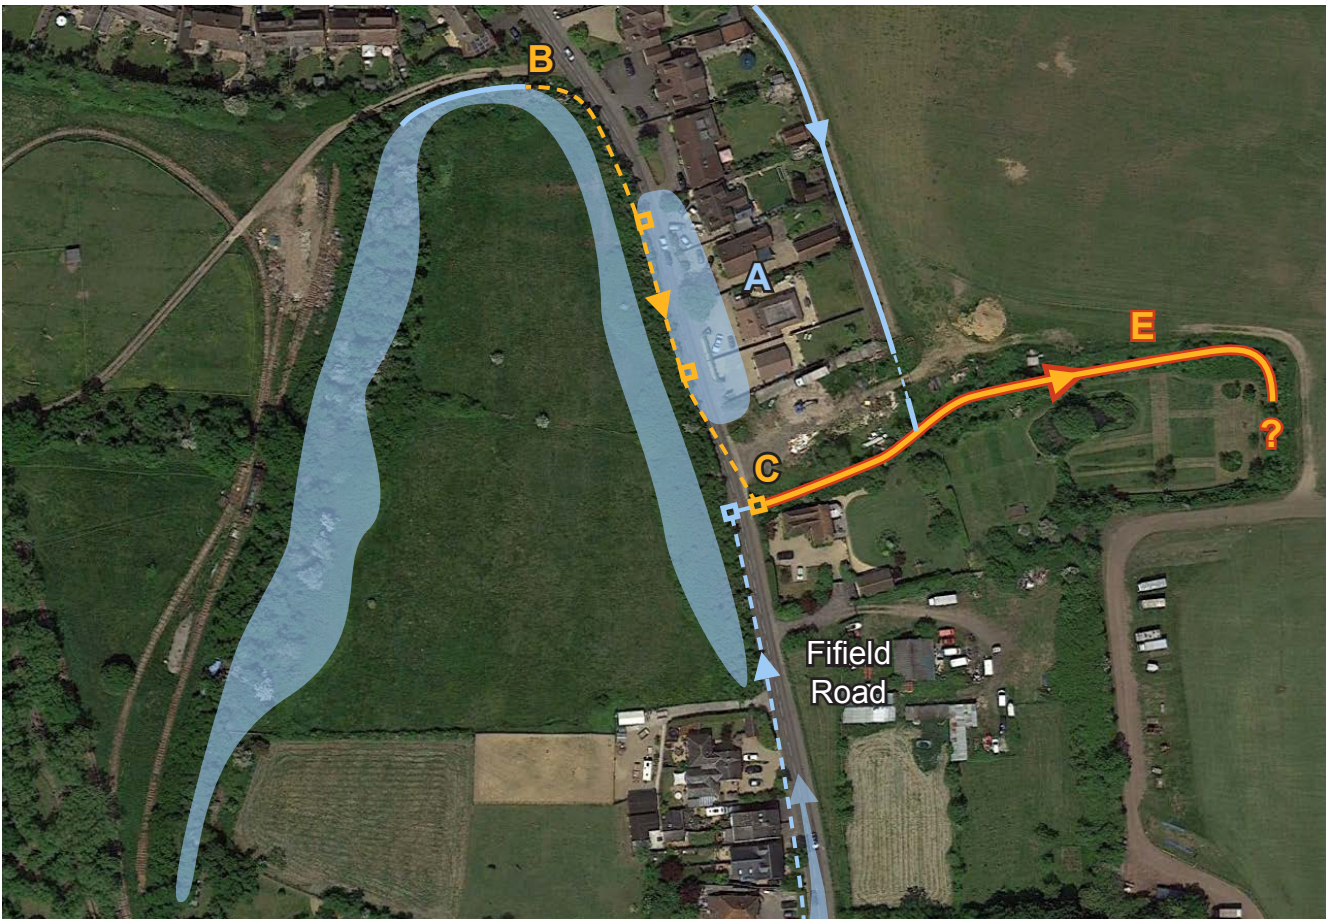
7 Fifield Road - Stewart Close to Garden Cottage

In 2001, 2003-2004, and again on Saturday 4 January 2014 flooding at **A** forced residents to barricade their properties and deploy pumps. OGAFCA then made this the priority location as the most residents and properties were threatened. A site meeting on March 27 2015 led to a Streetcare investigation and within an hour a Streetcare team were clearing and jetting drains and gullies along this stretch. Contrary to expectations the gullies on the west side of the road did not extend away from the road at all but merely lead into the ditch, which was virtually non-existent anyway.

Streetcare's investigations led them to a decision to pipe the whole length from **B** to the chamber at **C** and renew roadside gullies and curbs. However, they said that the outflow from the chamber **C** flowing eastward beside the boundary of Garden Cottage along ditch **E** towards the Polo pitch needed to be cleaned out or the system would still back up. We wrote to the Landowner and a site meeting took place on Thursday July 17 2014. The landowner, Mr Bennett, met with us and Streetcare on site and agreed to clear the ditch.

At the end of October 2014 Streetcare carried out work and the new gullies now feed into this new pipe and from there under the road to the chamber. The contractors reported that the ditch towards the polo pitch still needed to be cleaned out or water would back up in the new pipe. Streetcare contacted the landowner again who promised to carry out the necessary maintenance. Unfortunately as far as we are aware this work has still not yet been done but this location has a GREEN status until wet weather shows if it is still deficient.

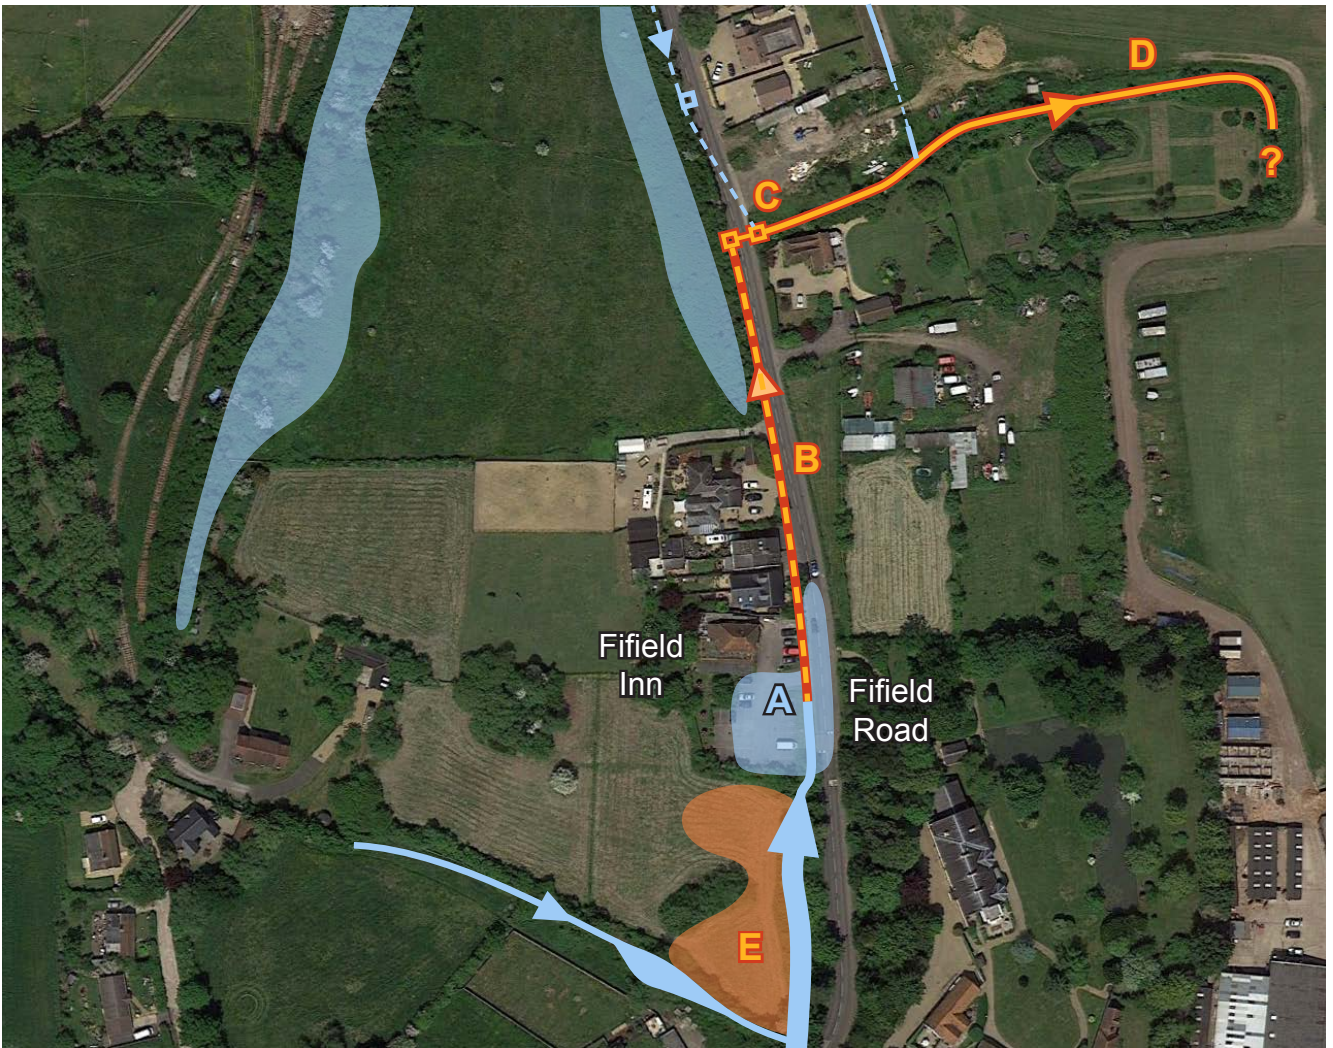
7B Fifield Inn - Fifield Road (south)

In common with many other places in the area the Fifield Inn car park (A) and Fifield Road flooded in 2001, 2003-2004, and again on Saturday 4 January 2014. But this location can flood quite frequently whenever there is a period of rainfall. In the original “9 Wet Spots” report this was included in “Wet Spot” 7 on the assumption that there were common causes and solutions with the problems further north up Fifield Road and south of Stewart Close.

At that time there was a complete misunderstanding of the very local fluid dynamics and it was assumed that all water flowing through the village was heading north trying to get to the Thames. During the Streetcare investigations in 2014 it was discovered that some water on Fifield Road actually flows SOUTH !

The common exit point for water south of Stewart Close is along a ditch heading east from (C) along the northern boundary of Garden Cottage towards (D) and the polo ground. At the end of 2014 Streetcare completed the project to address the northern part of this which has meant that “Wet Spot” 7 has been partially dealt with and has been given GREEN status. The southerly part has now been separated, renamed (7B), and still remains at RED.

Water entering the ditch between the car park (A) and the road far exceeds the volume that can be accommodated by its only route north via an underground pipe (B) from the south side of the entrance to the car park heading north to the chambers at (C). A first step is clearly to ensure that this whole route, including the outflow ditch towards the polo pitch (D) is flowing freely. That may not be sufficient to deal satisfactorily with the situation so it might be necessary to investigate creating a large sump area (E) to delay extreme flows.

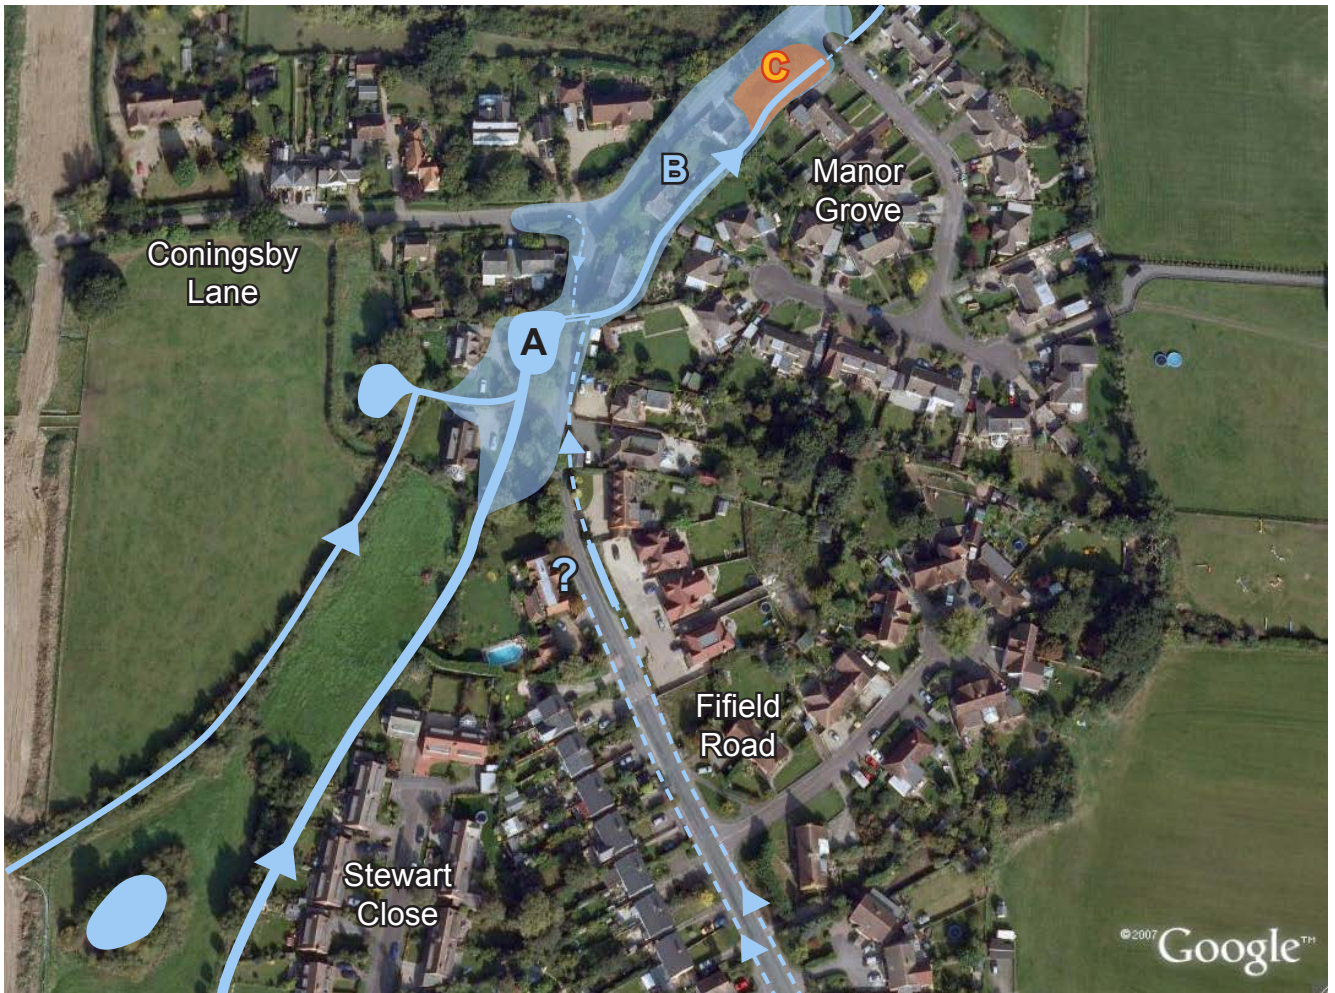
8 Culvert under road at Willow Creek - Fifield Road

Several drainage routes converge at a double culvert under the Fifield Road turning what is normally a stream through the front garden of *Willow Creek* into a large pond (A) in times of heavy rainfall. 70 years ago or more this really was a full time pond and there was a small road bridge allowing a substantial northward outflow (B).

At times of heavy rainfall this pinch point causes major flooding and as yet we have managed to achieve absolutely nothing that might improve the situation.

In fact it is very difficult to see how the onward flow from this point could be expanded to reduce the back-up. The route from what used to be the pond under the road via the culvert that was once a road bridge and then the constrained channel behind the old chapel and the Old Cottage to the culvert under Manor Grove and onwards cannot realistically be usefully expanded. Parish land at (C) gets flooded by backup from the Manor Grove culvert and might usefully be excavated as a holding pond to delay the point at which the property at (B) and the road become flooded. Similar space north of the Manor Grove culvert might be used in this way also to relieve pressure on "Wet Spot" 2 a little further north.

When the rain stops and levels begin to drop excess water now clears pretty speedily, much more quickly than it ever used to though it is not clear why that is.

The most obvious improvement to the onward flow of water for the whole area would be the installation of a major storm drain under the entire length of Fifield Road and on under the A308. But given the constraints of local government budgets this is clearly a fantasy.
