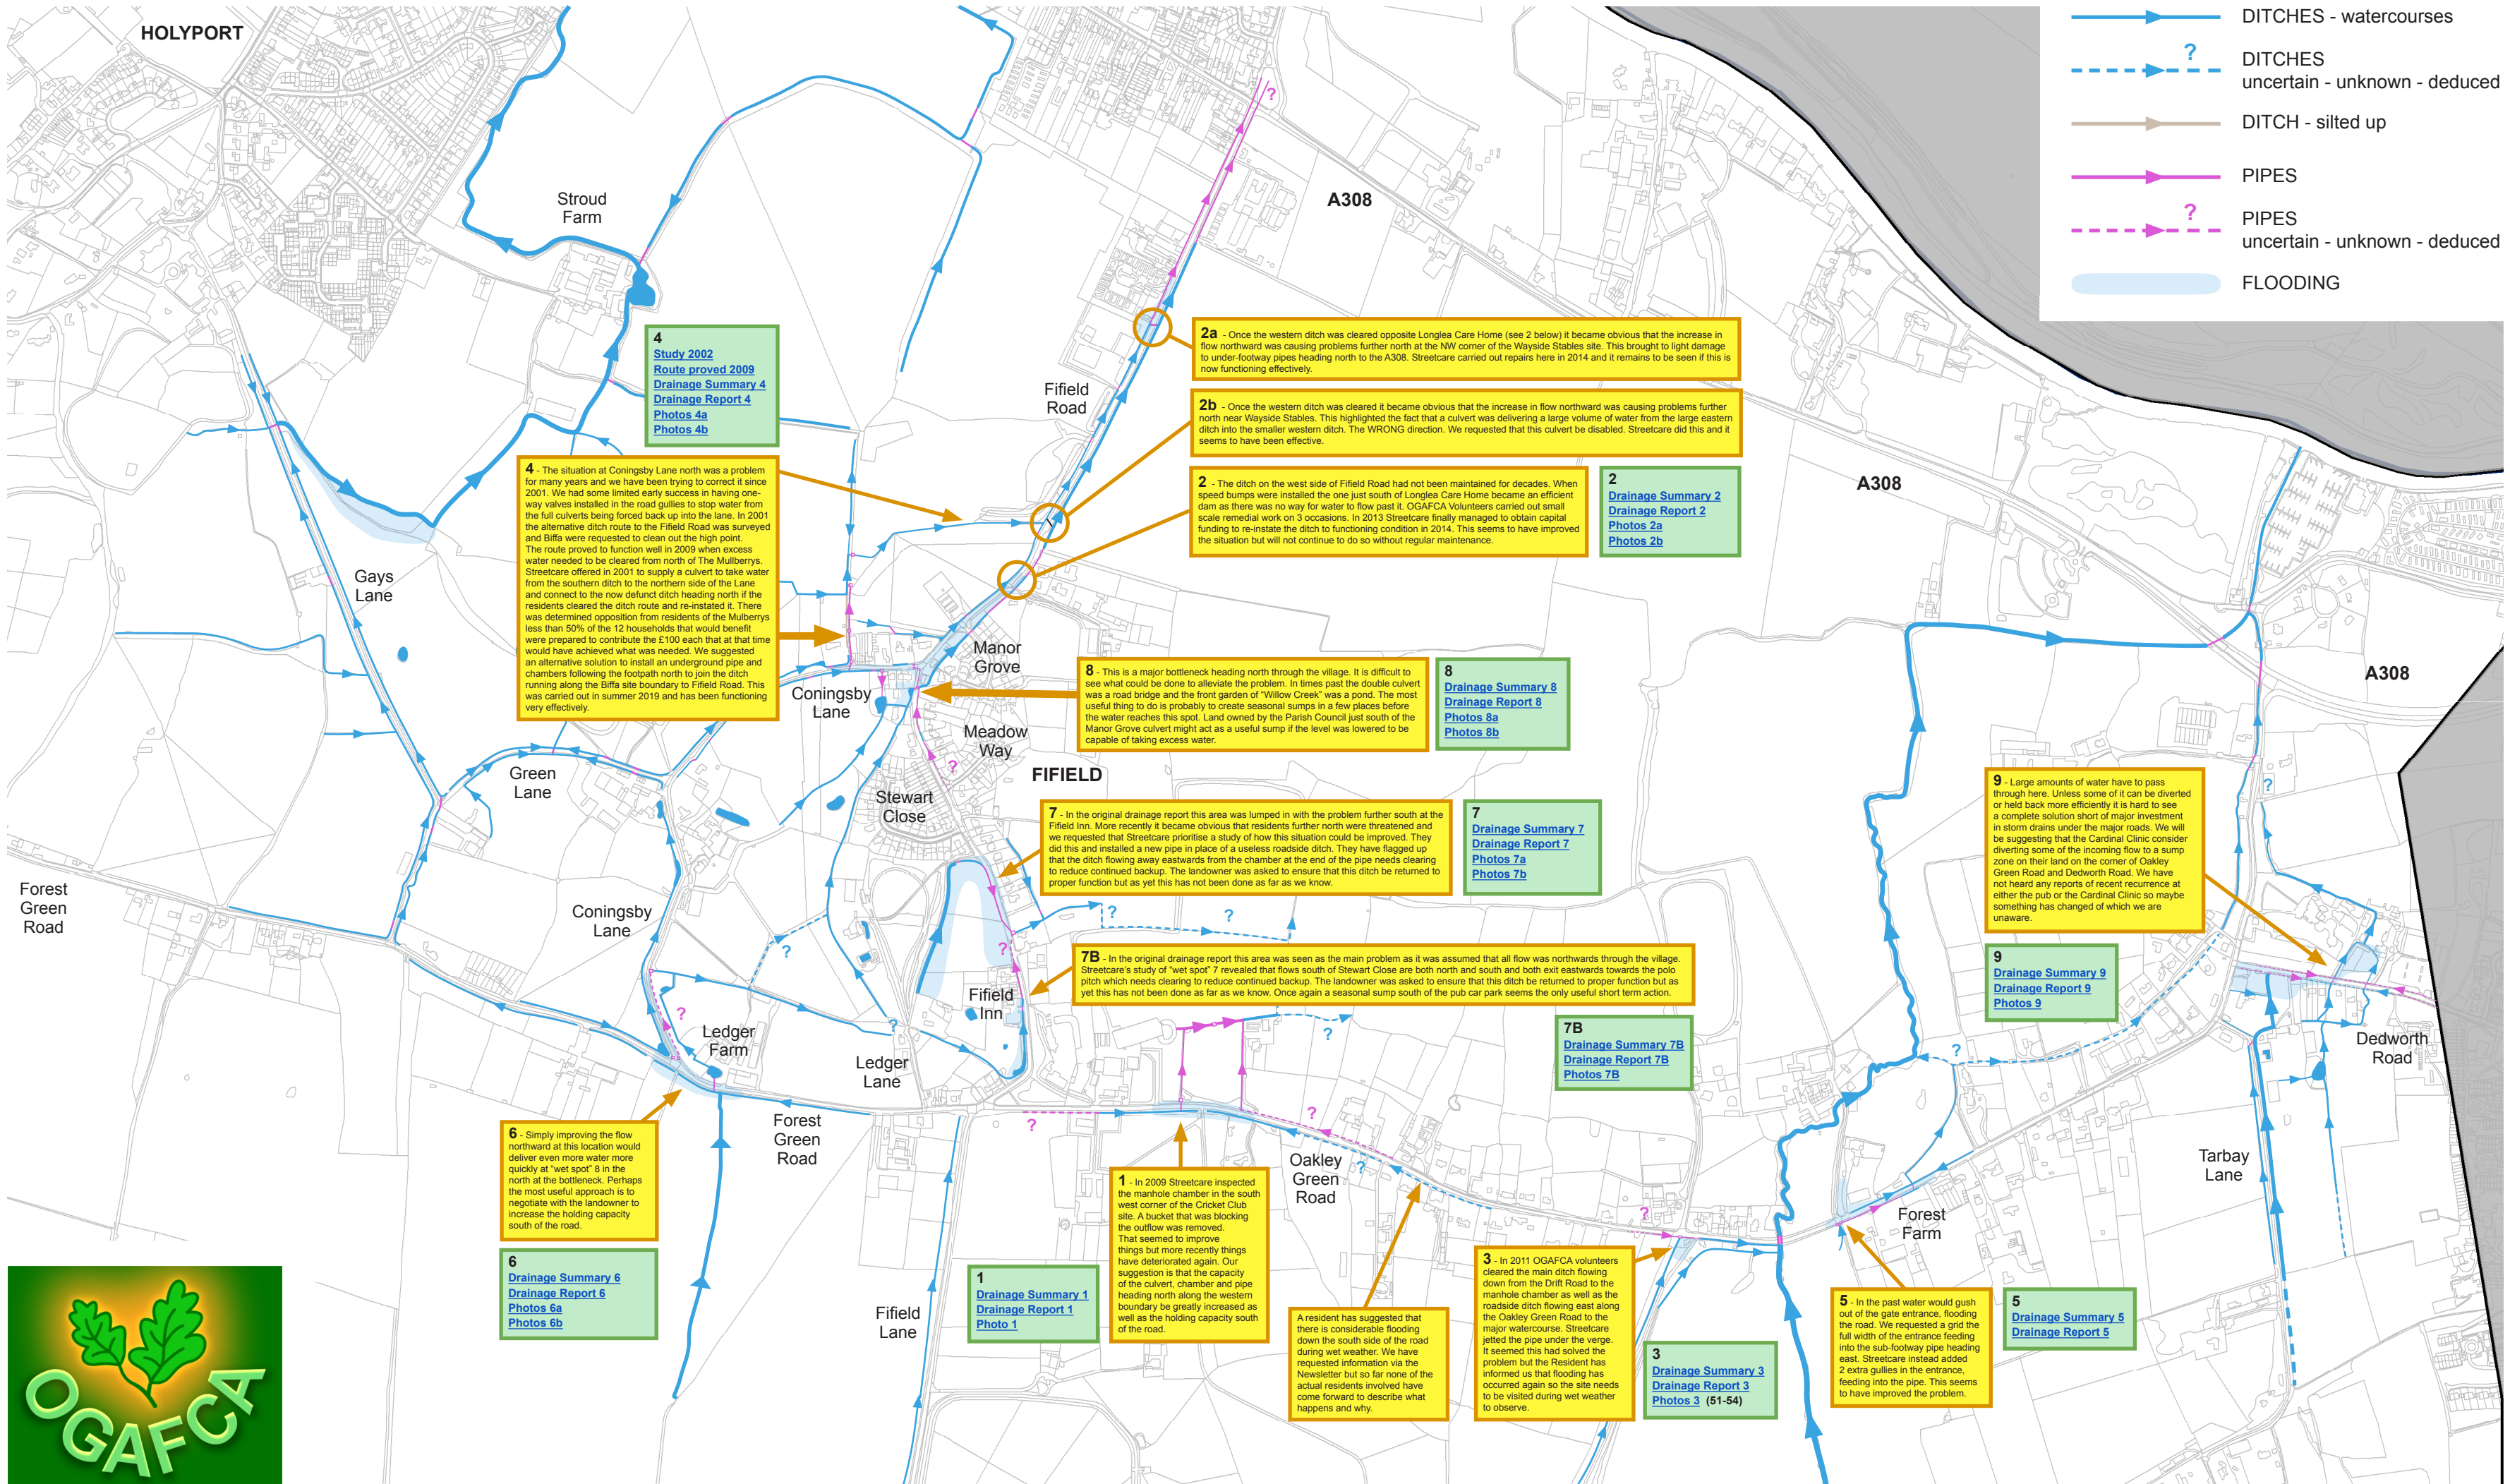
- DITCHES - watercourses
- DITCHES uncertain - unknown - deduced
- DITCH - silted up
- PIPES
- PIPES uncertain - unknown - deduced
- FLOODING

4 - The situation at Coningsby Lane north was a problem for many years and we have been trying to correct it since 2001. We had some limited early success in having one-way valves installed in the road gullies to stop water from the full culverts being forced back up into the lane. In 2001 the alternative ditch route to the Fifield Road was surveyed and Biffa were requested to clean out the high point. The route proved to function well in 2009 when excess water needed to be cleared from north of The Mulberrys. Streetcare offered in 2001 to supply a culvert to take water from the southern ditch to the northern side of the Lane and connect to the now defunct ditch heading north if the residents cleared the ditch route and re-instated it. There was determined opposition from residents of the Mulberrys less than 50% of the 12 households that would benefit were prepared to contribute the £100 each at that time would have achieved what was needed. We suggested an alternative solution to install an underground pipe and chambers following the footpath north to join the ditch running along the Biffa site boundary to Fifield Road. This was carried out in summer 2019 and has been functioning very effectively.

2a - Once the western ditch was cleared opposite Longlea Care Home (see 2 below) it became obvious that the increase in flow northward was causing problems further north at the NW corner of the Wayside Stables site. This brought to light damage to under-footway pipes heading north to the A308. Streetcare carried out repairs here in 2014 and it remains to be seen if this is now functioning effectively.

2b - Once the western ditch was cleared it became obvious that the increase in flow northward was causing problems further north near Wayside Stables. This highlighted the fact that a culvert was delivering a large volume of water from the large eastern ditch into the smaller western ditch. The WRONG direction. We requested that this culvert be disabled. Streetcare did this and it seems to have been effective.

2 - The ditch on the west side of Fifield Road had not been maintained for decades. When speed bumps were installed the one just south of Longlea Care Home became an efficient dam as there was no way for water to flow past it. OGAFCA Volunteers carried out small scale remedial work on 3 occasions. In 2013 Streetcare finally managed to obtain capital funding to re-instate the ditch to functioning condition in 2014. This seems to have improved the situation but will not continue to do so without regular maintenance.

8 - This is a major bottleneck heading north through the village. It is difficult to see what could be done to alleviate the problem. In times past the double culvert was a road bridge and the front garden of "Willow Creek" was a pond. The most useful thing to do is probably to create seasonal sumps in a few places before the water reaches this spot. Land owned by the Parish Council just south of the Manor Grove culvert might act as a useful sump if the level was lowered to be capable of taking excess water.

7 - In the original drainage report this area was lumped in with the problem further south at the Fifield Inn. More recently it became obvious that residents further north were threatened and we requested that Streetcare prioritise a study of how this situation could be improved. They did this and installed a new pipe in place of a useless roadside ditch. They have flagged up that the ditch flowing away eastwards from the chamber at the end of the pipe needs clearing to reduce continued backup. The landowner was asked to ensure that this ditch be returned to proper function but as yet this has not been done as far as we know.

7B - In the original drainage report this area was seen as the main problem as it was assumed that all flow was northwards through the village. Streetcare's study of "wet spot" 7 revealed that flows south of Stewart Close are both north and south and both exit eastwards towards the polo pitch which needs clearing to reduce continued backup. The landowner was asked to ensure that this ditch be returned to proper function but as yet this has not been done as far as we know. Once again a seasonal sump south of the pub car park seems the only useful short term action.

9 - Large amounts of water have to pass through here. Unless some of it can be diverted or held back more efficiently it is hard to see a complete solution short of major investment in storm drains under the major roads. We will be suggesting that the Cardinal Clinic consider diverting some of the incoming flow to a sump zone on their land on the corner of Oakley Green Road and Dedworth Road. We have not heard any reports of recent recurrence at either the pub or the Cardinal Clinic so maybe something has changed of which we are unaware.

6 - Simply improving the flow northward at this location would deliver even more water more quickly at "wet spot" 8 in the north at the bottleneck. Perhaps the most useful approach is to negotiate with the landowner to increase the holding capacity south of the road.

1 - In 2009 Streetcare inspected the manhole chamber in the south west corner of the Cricket Club site. A bucket that was blocking the outflow was removed. That seemed to improve things but more recently things have deteriorated again. Our suggestion is that the capacity of the culvert, chamber and pipe heading north along the western boundary be greatly increased as well as the holding capacity south of the road.

3 - In 2011 OGAFCA volunteers cleared the main ditch flowing down from the Drift Road to the manhole chamber as well as the roadside ditch flowing east along the Oakley Green Road to the major watercourse. Streetcare jettied the pipe under the verge. It seemed this had solved the problem but the Resident has informed us that flooding has occurred again so the site needs to be visited during wet weather to observe.

5 - In the past water would gush out of the gate entrance, flooding the road. We requested a grid the full width of the entrance feeding into the sub-footway pipe heading east. Streetcare instead added 2 extra gullies in the entrance, feeding into the pipe. This seems to have improved the problem.
