Oakley Green, Fifield & District Community Association Ltd

<u>Application number 17/00997/CONDIT for discharge of Condition 6 concerning drainage for planning permission 15/02107 for the relocation of the Phoenix Gym to land north of Longlea, Fifield Road, Fifield, Berks</u>

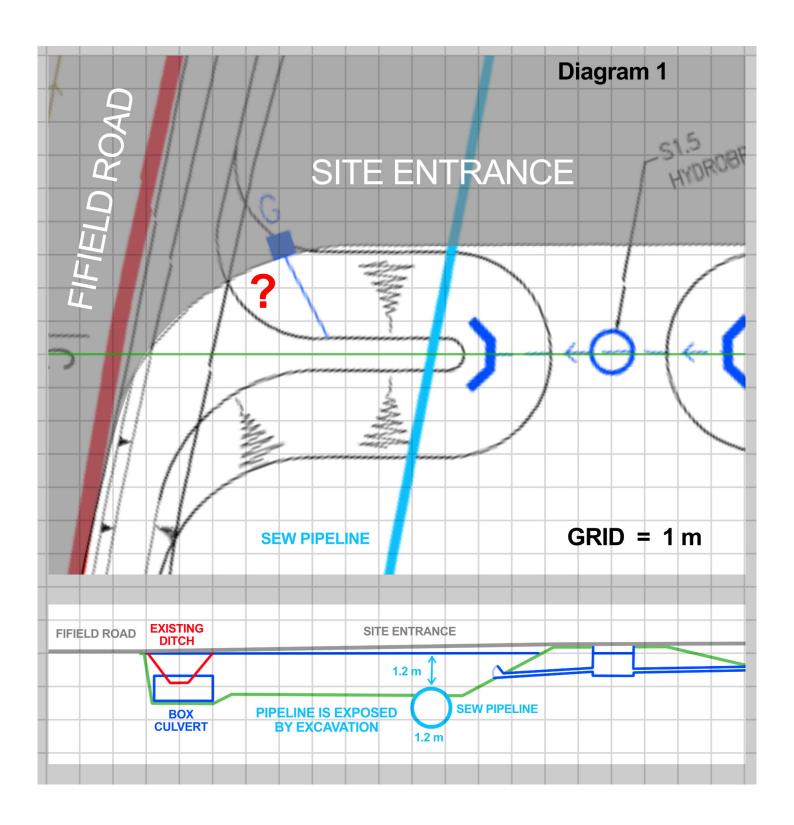
Please see Diagram 1 and Diagram 2 on the following pages

5b - The box culvert is shown as lying half a meter below the bottom of the existing ditch and the top of the box culvert is shown as barely above the bottom of the existing ditch. So in reality the existing ditch will need to be sloped down an additional half meter on either side to meet the bottom of the box culvert. Prevailing conditions in the existing ditch mean that it won't be long before the lower area is rapidly silting up and will need constant maintenance and cleaning out.

5c - The flap outlet into the new excavation off the existing ditch is shown as being approximately 0.6 m or 0.7 m below the surface. Conditions in most wet seasons mean that this will be under water for long periods of time preventing discharge unless the outflow is pumped under pressure which does not appear to be a suggestion at present.
